DAVID P. POPE, PH.D.

RE: Revak v. Locatum, et al

I am writing to report to you the results of my investigation into the cause(s) of the sling failure in the subject accident.

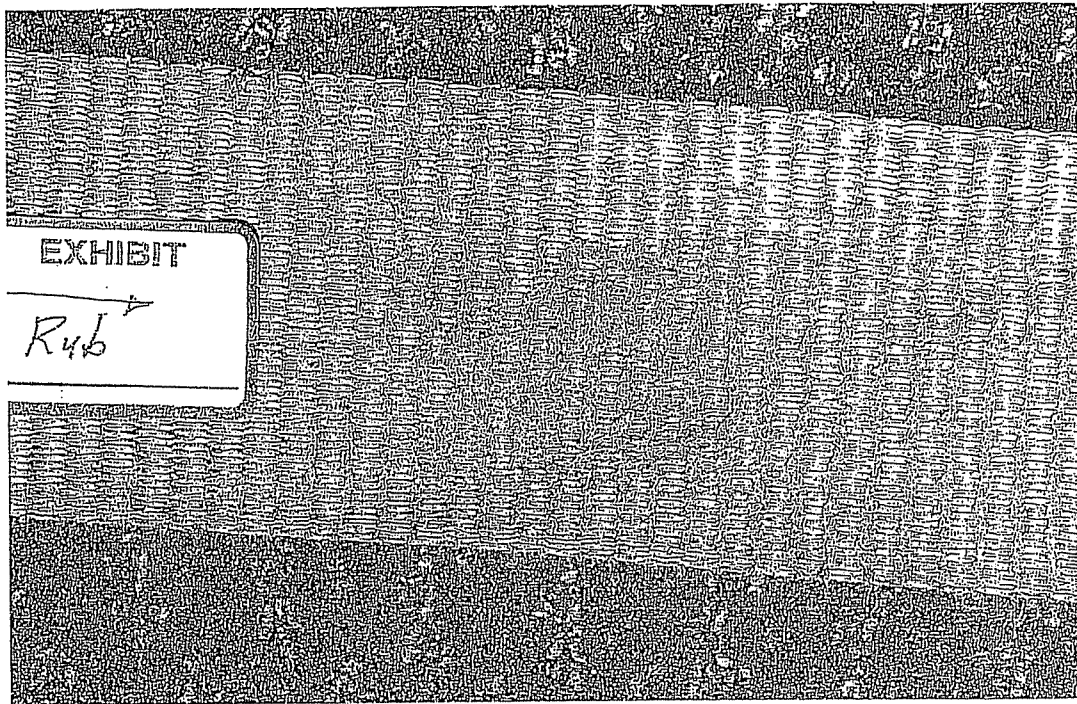
Except for the fracture in the subject sling and a deliberate cut made after the accident, the sling shows little damage. The surface of the sling is abraded in some areas, but only a very small fraction of the fibers is significantly damaged. Also, some fibers are cut in some localized areas, but, again, the number of cut fibers is a very small fraction of the total. Since the strength of the sling is determined by the fraction of undamaged fibers, the damage to the fibers outside the failure zone reduced the breaking strength of the sling by only a few percent. Samples of this damage are shown in Photographs #1 and 2.

Photograph #1. An area of abrasive wear on the sling. Note the absence of cut fibers.

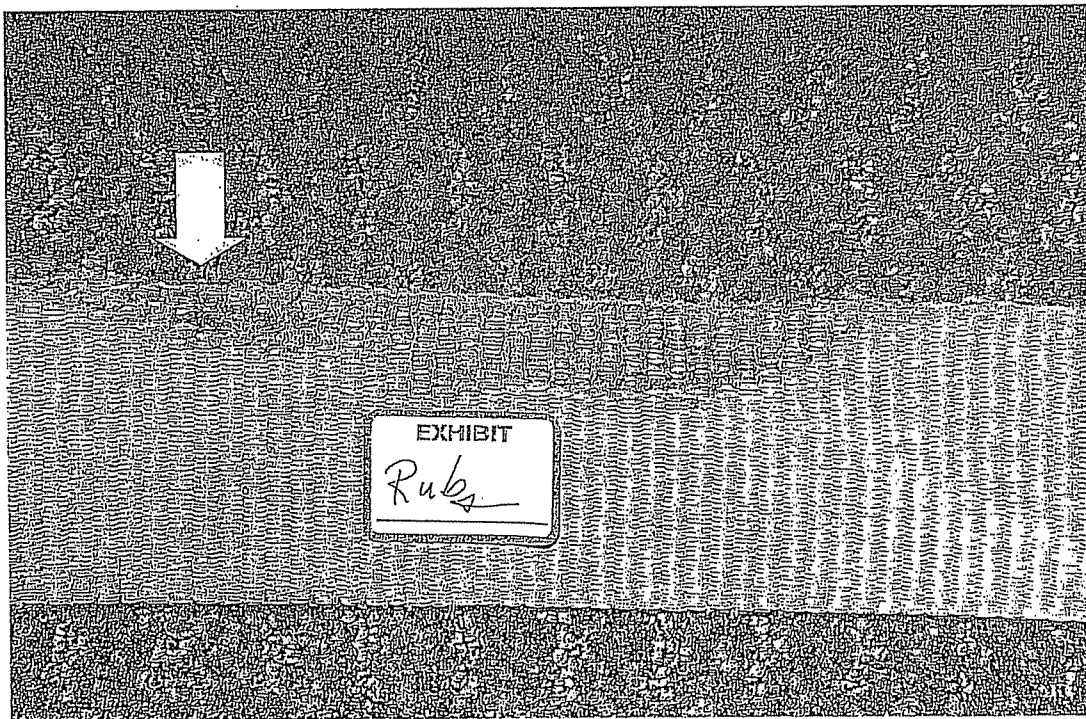
Photograph #2. An area of abrasive wear with some cut fibers, see arrow.

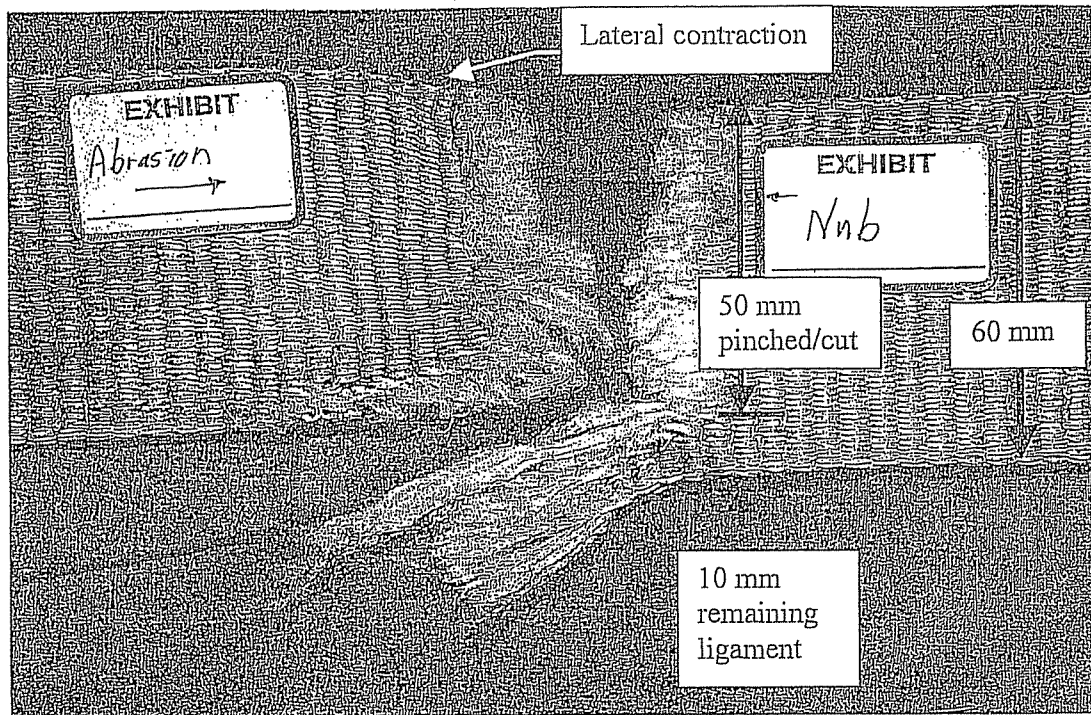
I now consider the specific area of the fracture, as shown in Photograph 3. This photograph shows the two sides of the fracture placed end to end in their correct relative orientations. Most of the fracture surfaces consist of a relatively straight portion that is perpendicular to the axis of the sling. The length of this section is about 50 mm of the 60 mm width of the strap, indicated by 'pinched/cut' on the photograph. The second portion of the fracture surface consists of a 10 mm wide 'tail' attached to the right side with a matching area on the left side. In addition, the 50 mm long section on the left side underwent considerable lateral contraction, as shown in the photograph, while the right side underwent little or no contraction. The absence of lateral contraction on the right hand side indicates that this side was subjected to much smaller loads at failure than the left hand side. Furthermore, the left side of the fracture is abraded in the direction shown, and this abrasion terminates on a 'nub' of polypropylene fibers on the right side of the fracture. All these features point to the fact that the 50 mm long portion of the fracture resulted from the sling having been pinched between a fixed object and the load during lifting. Under such a condition, the left side of the fracture was placed under very high stress while the right side bore a much smaller load, resulting in both the pinching/cutting of the sling along the 50 mm length of the fracture and the lateral contraction on the left hand side. After the sling was cut, no more than a 10mm wide section of the sling was carrying the load, see '10 mm wide remaining ligament' on the photograph.

Based on the above observations of the fracture surface and the surrounding area, I conclude that the damage reduced the strength of the sling by at least 80%.

The two sides of the fracture in Photograph #3 show no other differences, for example, no differences in soiling, indicating that the damage to the sling occurred relatively

Given that the sling was so severely damaged prior to the accident, and that it failed while the load was just being slightly repositioned, it is highly unlikely that it could have withstood the forces required to lift the draft out of the ship. Therefore the damage occurred during the lift itself, i.e., the draft pinched the sling against a portion of the ship while it was being lifted from the ship in Philadelphia.

Photograph #3. The fracture site on the sling. Prior to the accident 50mm of the 60 mm cross section was cut, leaving only a 10 mm remaining ligament to carry the load.
